## ARLINGTON SCHOOL DISTRICT ARLINGTON HIGH SCHOOL, A BUILDING ASBESTOS SUMMARY

### **KNOWN AND POSSIBLE asbestos-containing building materials at the Arlington School District's Arlington High School, A Building. (DO NOT DISTURB THESE MATERIALS.)**

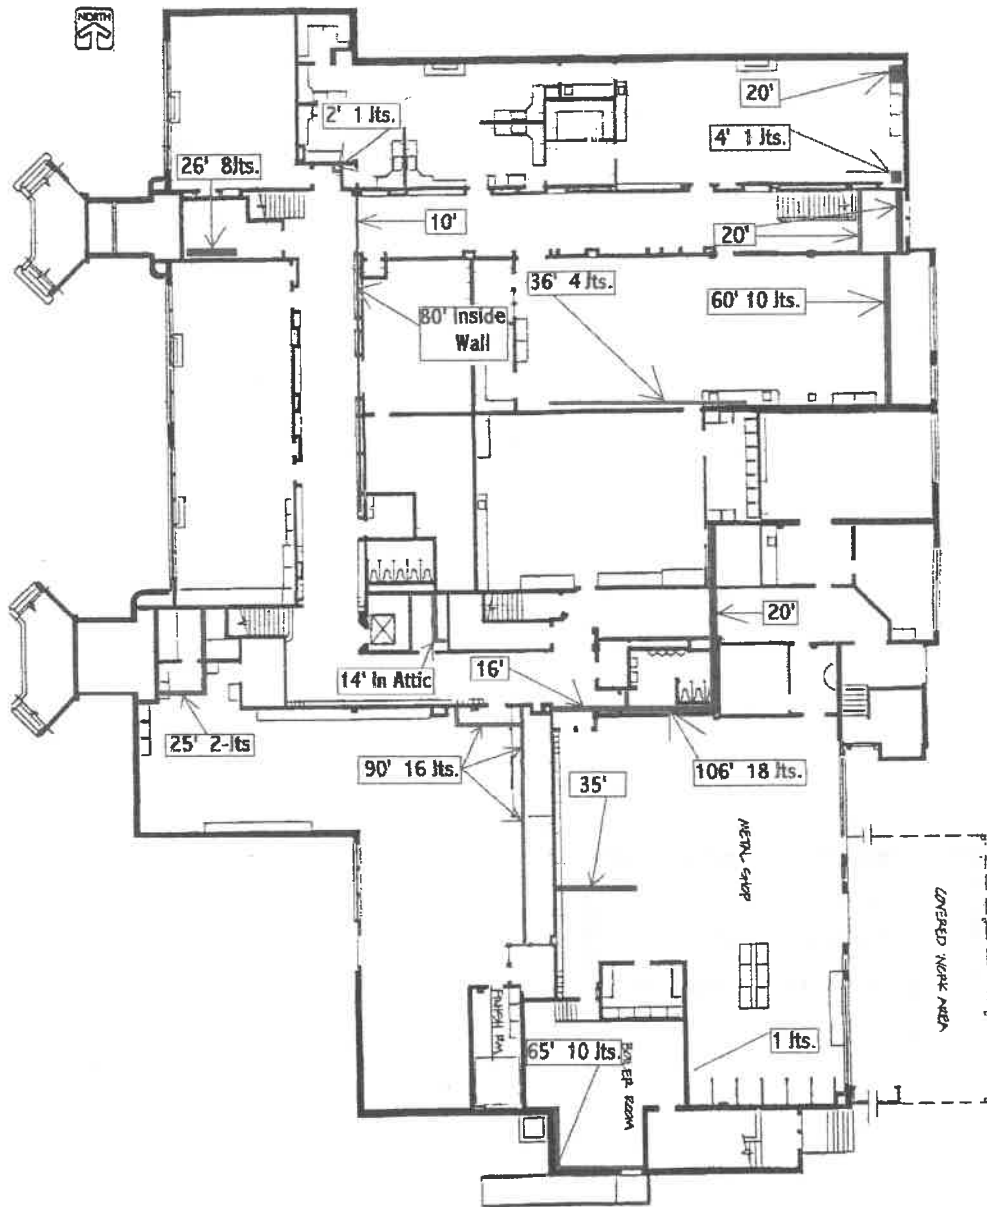
Arlington High School  
A Building, 1st Floor  
TSI Locations

This site plan is not meant to be all inclusive of the TSI locations. TSI is hidden in walls and could be hidden elsewhere in this building.

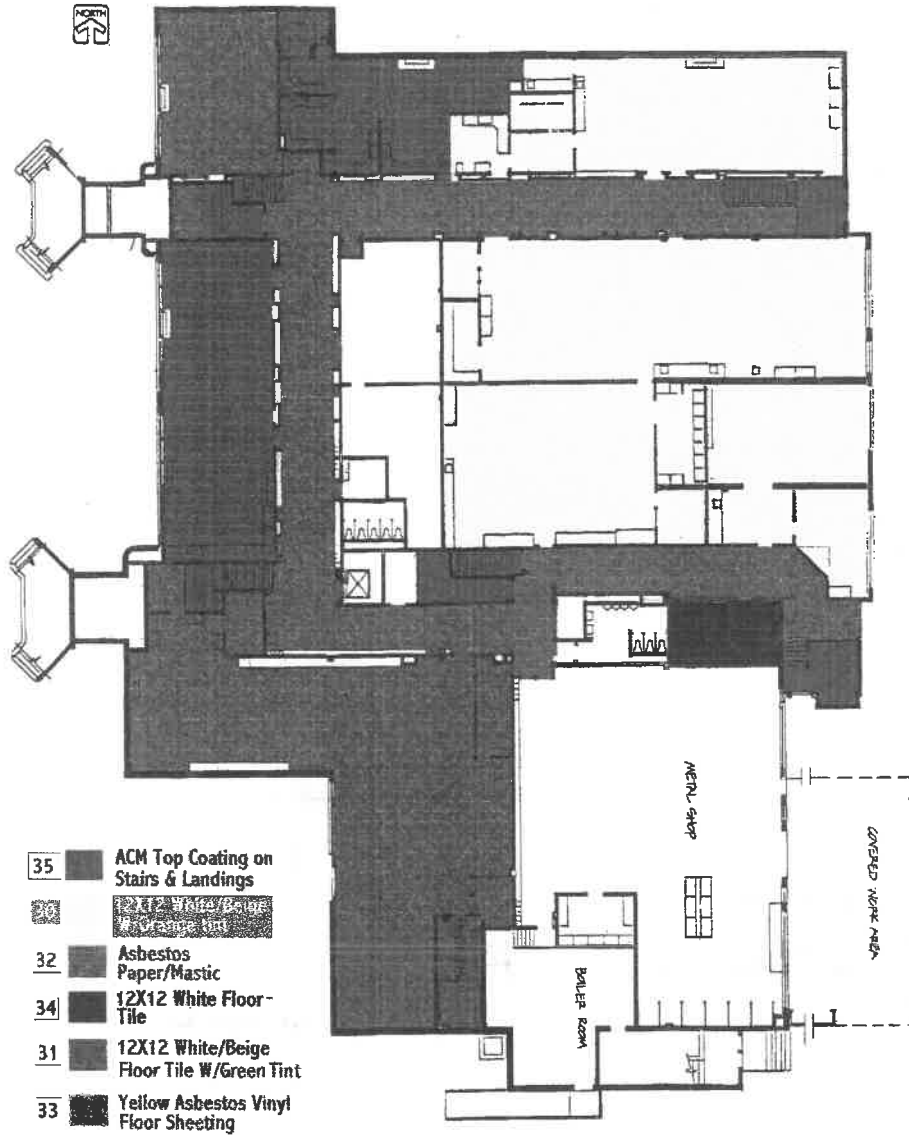
Arlington High School  
A Building 1st Floor  
Asbestos  
Flooring Materials

- 35 ACM Top Coating on Stairs & Landings
- 32 Asbestos Paper/Mastic
- 34 12X12 White Floor-Tile
- 31 12X12 White/Beige Floor Tile W/Green Tint
- 33 Yellow Asbestos Vinyl Floor Sheeting

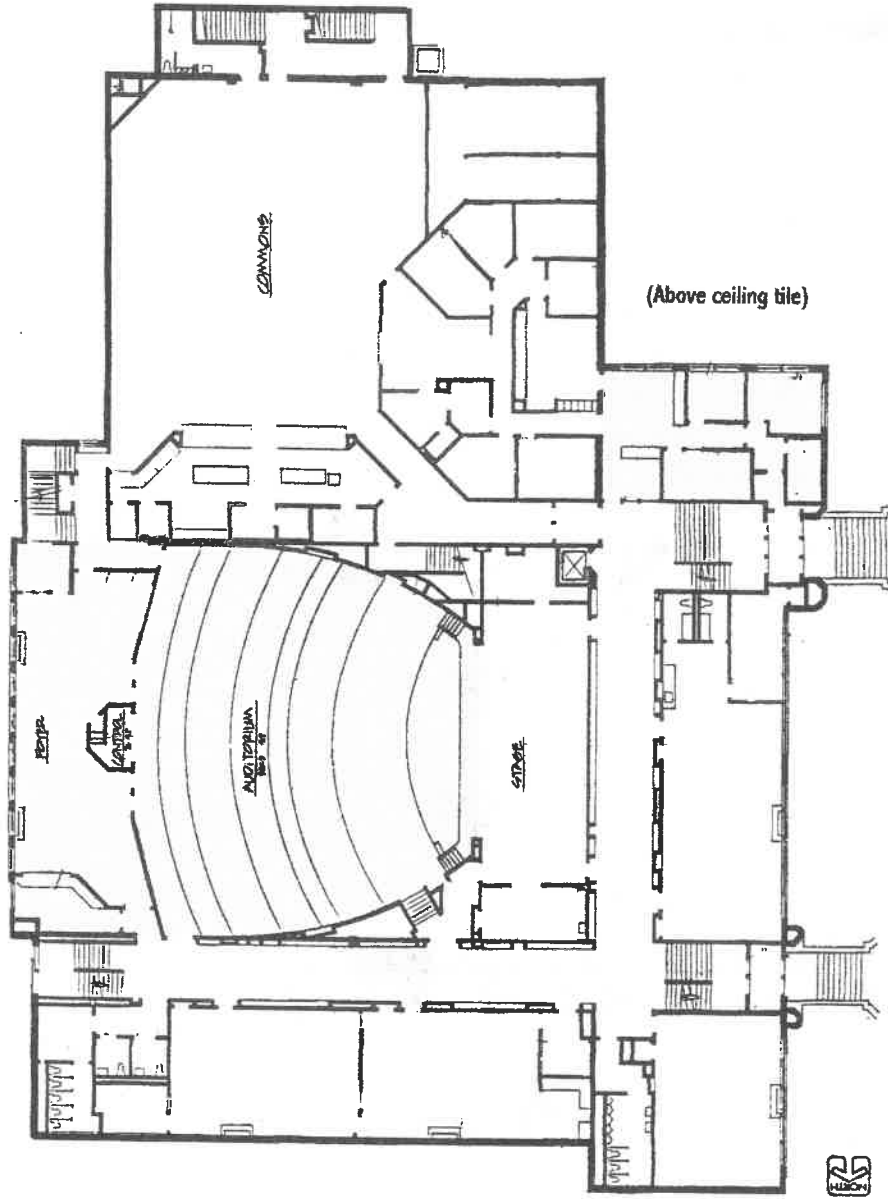
**Arlington High School  
A Building - Surfacing  
Asbestos-Acoustical  
Plaster Locations  
2nd Floor**

- #11 Surfacing materials include the acoustical plaster that was used during the original construction in the auditorium, on the walls and ceiling. This surfacing material will also be found in the foyer to the auditorium and the main offices on the second floor. There was previous estimated to be 8200 square feet of this material. There is approximately 1,600 additional square feet of this acoustical plaster discovered during this inspection. (See site plan for locations.) This material has been painted many times and is in a non-friable state when not disturbed. However, this material has high potential for disturbance and could be easily disturbed. Awareness training must be given to all staff that might disturb this plaster.

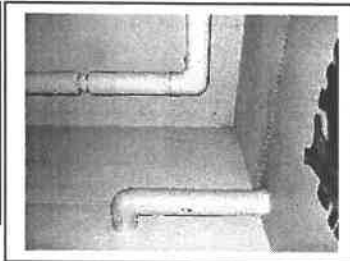
< Non-asbestos & asbestos TSI together

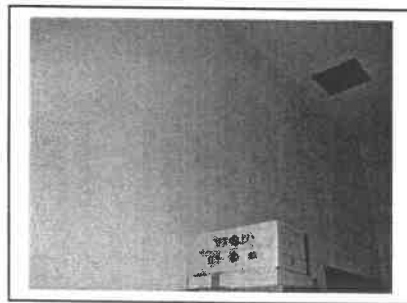
- BUILDING:** Arlington High School, A Building
- FUNCTIONAL AREA:** Science storage room, third floor. (See site plan.)
- LOCATION:** On the walls of room. (See site plans.)
- DESCRIPTION:** Stucco like finish on walls of the science storage room. This surfacing material was not found in any other room of the building and is probably an addition to the building following the original construction. It is very hard and when I tested, is in a non-friable state. It will be contained in the surveillance program and maintained as an asbestos, friable material.

Asbestos stucco

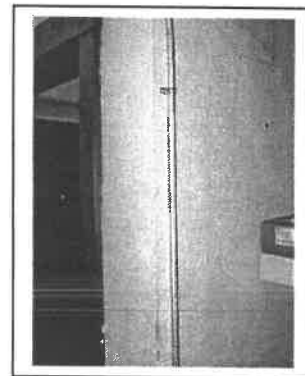
Asbestos stucco finish

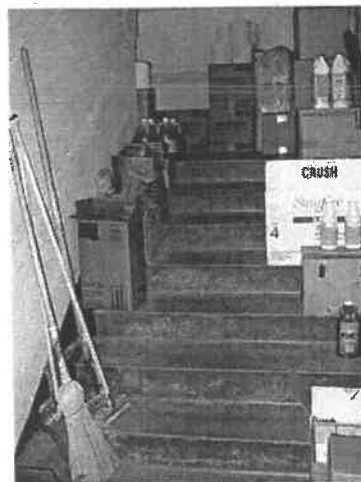
**Photo shows steps from basement floor to where this material was sampled.**

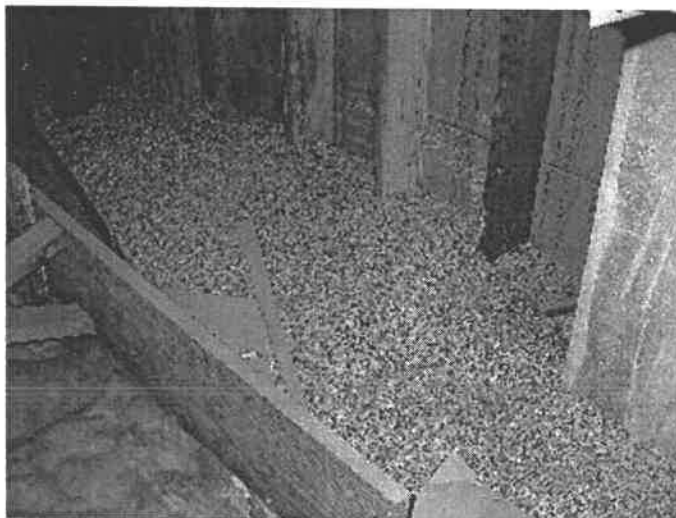
**DESCRIPTION:** This vermiculite insulation was found in the attic area and suspected to have been added to the building during some of the modernizations to the building. The material that was found in the attic is less than 1% asbestos. If more is found during any demolition activities, an asbestos consultant should sample and determine if hidden vermiculite is ACM.

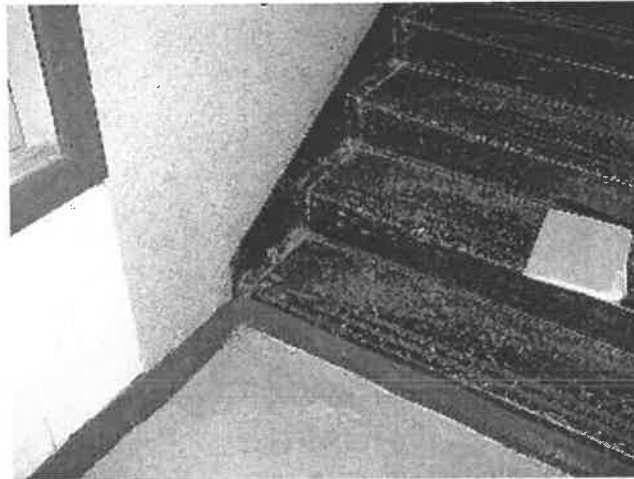
**DESCRIPTION:** This stair tread adhesive is an asbestos containing mastic. The rubber stair tread is non-asbestos.

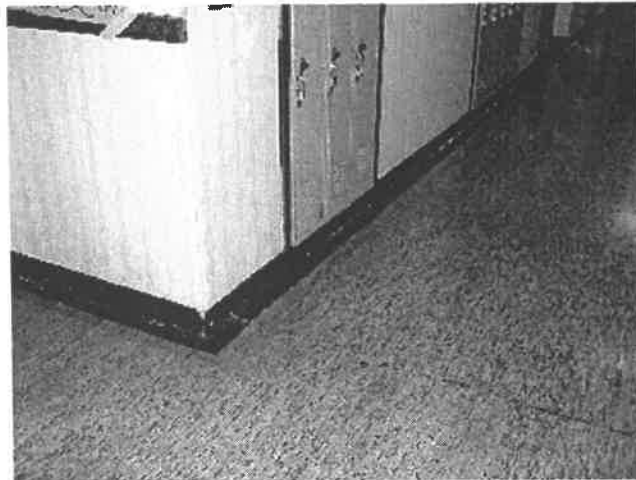
**DESCRIPTION:** This cement cove-base is located throughout the building. It can be seen where the samples were taken. It appears to be black in its original color, as seen in the photo below.

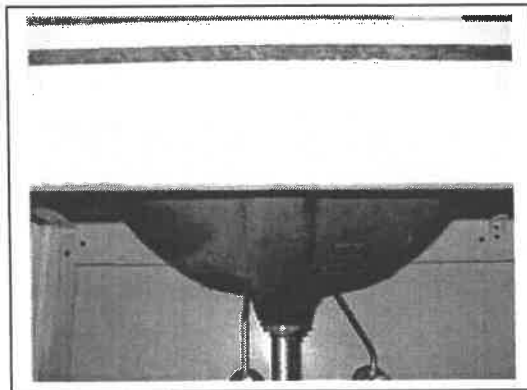
**DESCRIPTION:** This black sink insulation is known to be a asbestos containing material. It also appears to black in its original color as seen below.

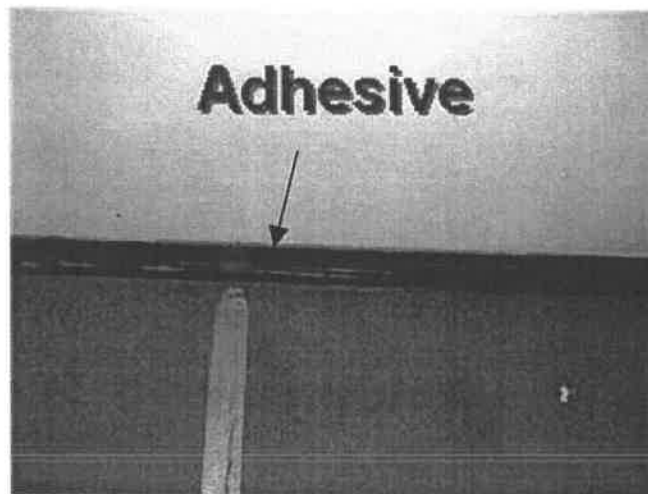
**DESCRIPTION:** This black or brown adhesive used to adhere the rubber cove base throughout the building is known to be a asbestos containing material. It is black or brown in its original color, as seen below. All brown / black cove base adhesive is asbestos containing in this building.

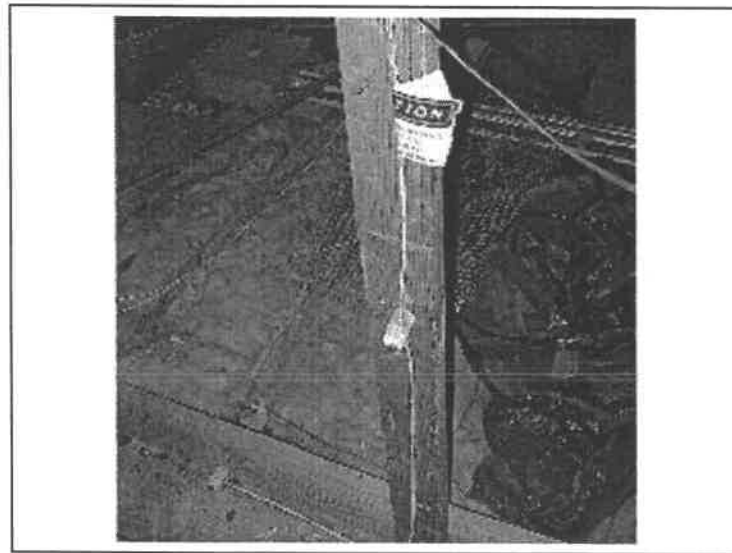
**DESCRIPTION:** Traditional knob & tube wiring is known to be a asbestos material. This type of wiring is not thought to be asbestos because of the appearance of the insulation on the wire. One sample is not enough to show all of the wiring to be non-asbestos and therefore, this wiring material will be presumed ACM. During demolition, further sampling should be performed.

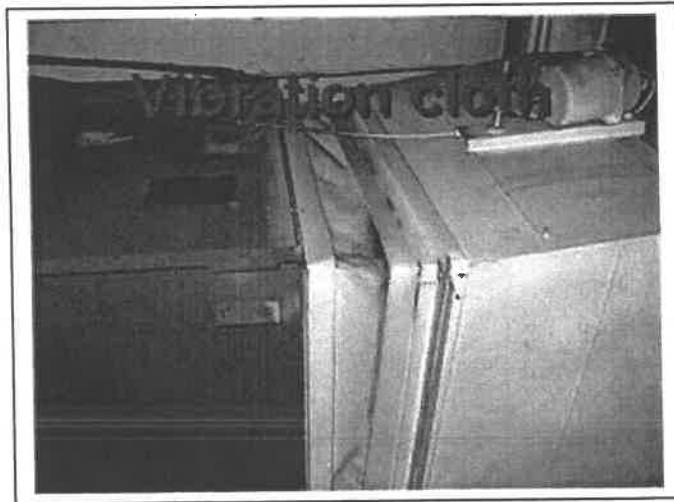
**DESCRIPTION:** Traditional cloth flex connectors on mechanical ductwork as seen below. All canvas and or cloth connectors will be presumed asbestos containing materials. During demolition, further sampling should be performed.

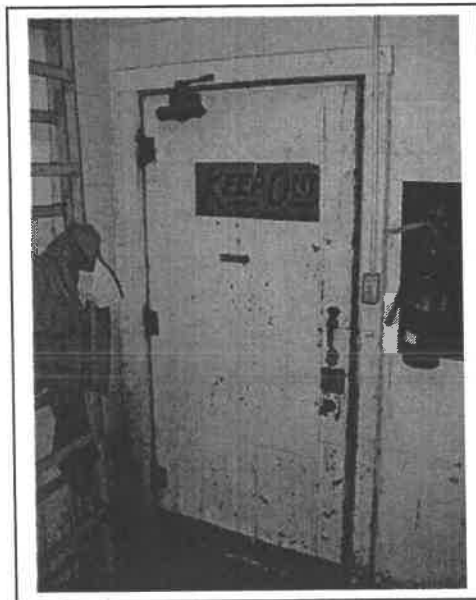
**DESCRIPTION:** Fire-doors are presumed to be an asbestos containing building material. Check for a label on all doors prior to working on. If working on a door where a fire-door would have been required by code (boiler room, chemical area or garage type of area) use caution prior to beginning the work and examine the door closely. If working on a door and cardboard or white powder is seen, stop and have inspected by an accredited asbestos inspector.

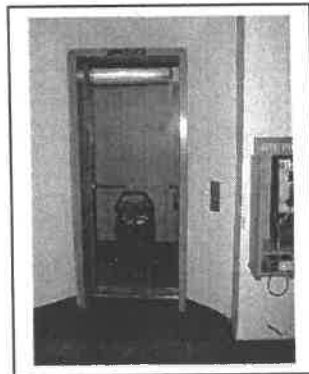
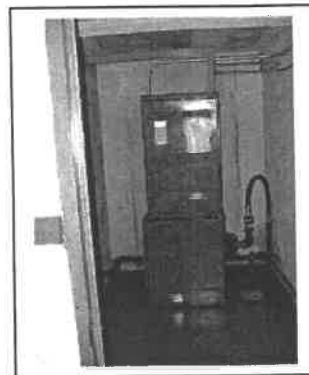
DESCRIPTION: All gasket materials and brake shoes are assumed to be asbestos containing and should be sampled prior to working on or replacing. (The elevator was installed in 1979 and may be non-asbestos.) Elevator coach shown below left and the mechanical portion of the elevator is below right.

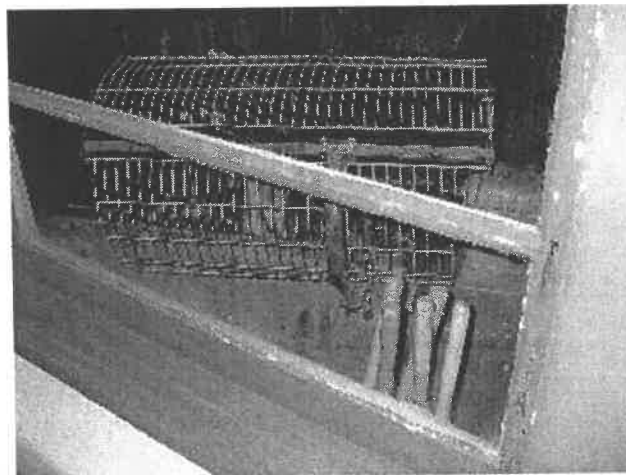
DESCRIPTION: All window putty is assumed to be asbestos containing and should be worked on as an asbestos containing materials when work is required.

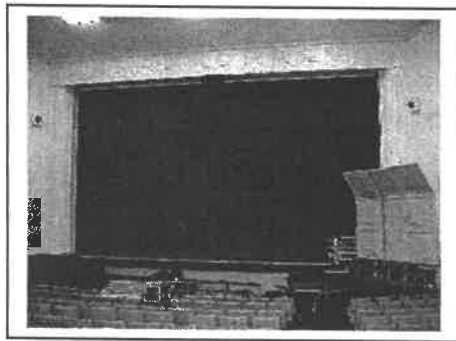
**DESCRIPTION:** Stage curtain is a "presumed asbestos containing material" and should be handled as asbestos containing or sampled prior to working on or replacing.

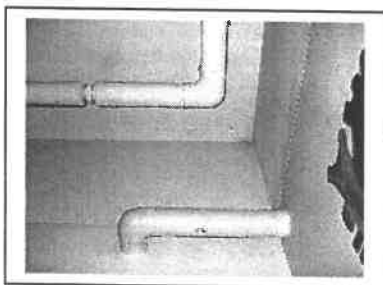
Newer fiberglass TSI above with original asbestos TSI below.

Hidden in wall

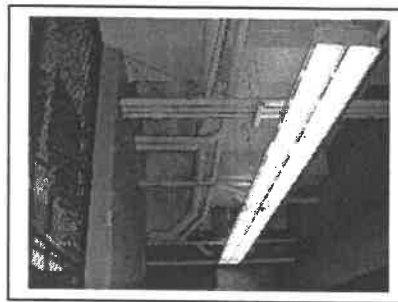
Metal shop TSI

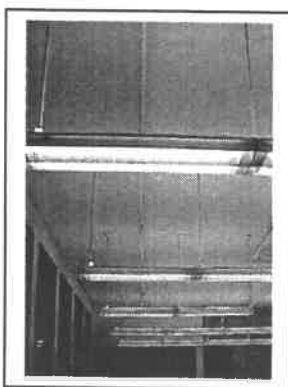
The surfacing acoustical plaster is located on the walls and ceiling of the auditorium, in the foyer of the auditorium and in the main offices above the ceiling tiles. Photo's below show the locations of this material.
