## ARLINGTON SCHOOL DISTRICT ARLINGTON HIGH SCHOOL, A BUILDING ASBESTOS SUMMARY

### **KNOWN AND POSSIBLE asbestos-containing building materials at the Arlington School District's Arlington High School, A Building. (DO NOT DISTURB THESE MATERIALS.)**

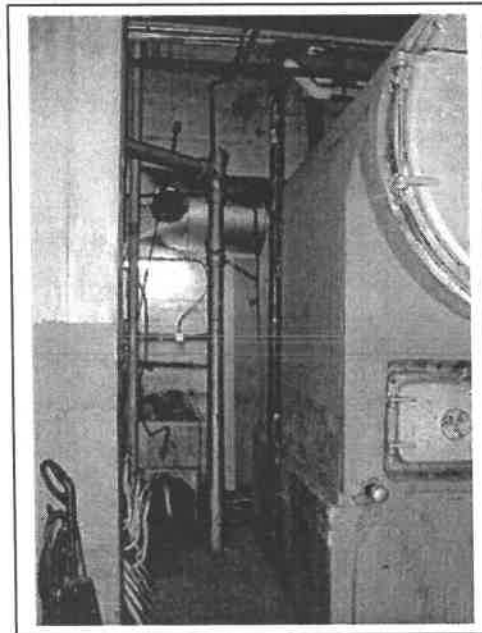
**DESCRIPTION:** The thermal system insulation that is on the boiler. This material has been sampled on two occasions and shown to be a non-asbestos material through three samples. Caution should be exercised during removal to assure residue is not left from original abatement of the potentially asbestos TSI. (If abated.)

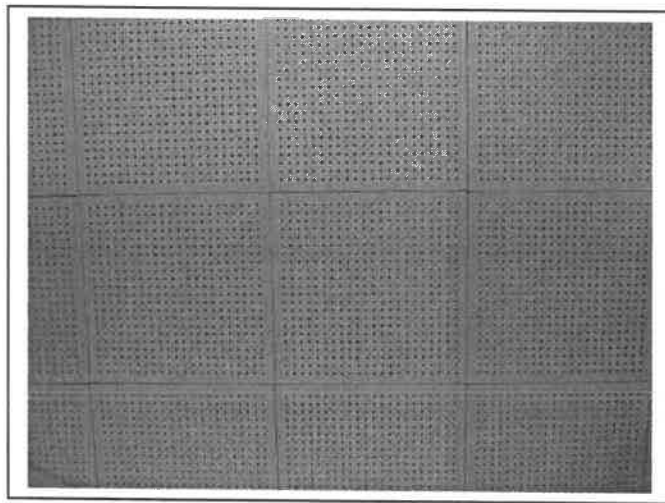
**DESCRIPTION:** 12 X 12 Ceiling tile, small ordered holed with border & dark brown adhesive. See photo's below. (No ceiling tile or mastic in this building was discovered to contain asbestos.)

**NO ASBESTOS**

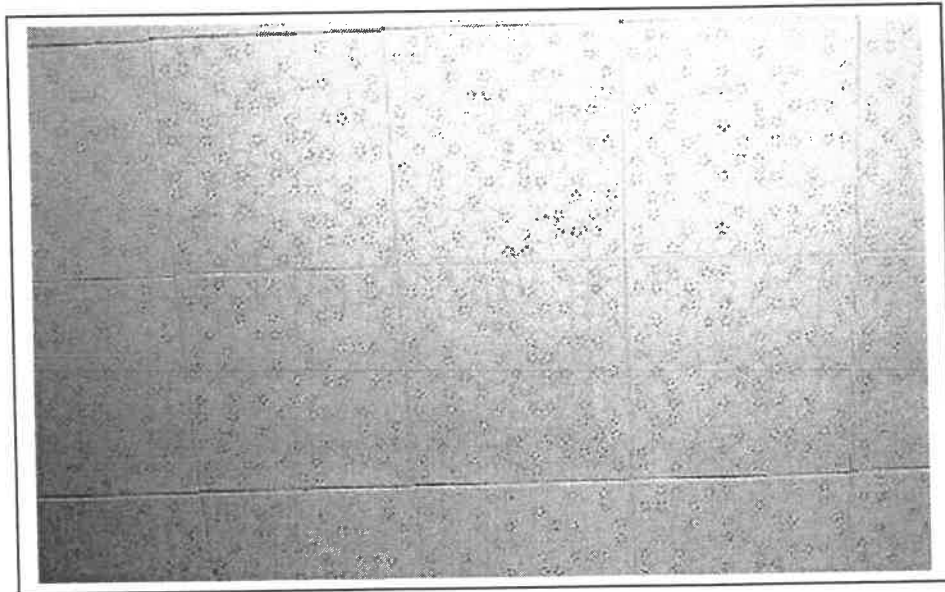
DESCRIPTION: 12 X 24 Ceiling tile, smooth face w/ small swirled hole & dark brown adhesive. See photo's below. (No ceiling tile or mastic in this building was discovered to contain asbestos.)

**NO ASBESTOS**

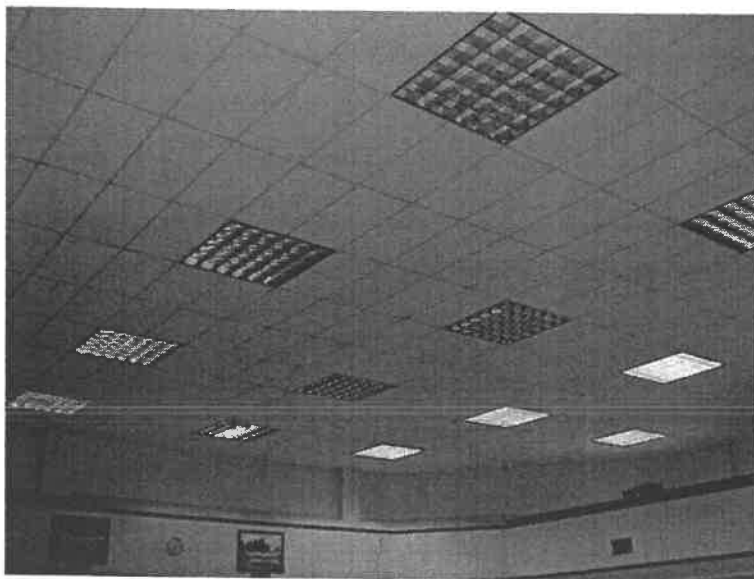
- BUILDING:** Arlington High School, A Building where this ceiling tile is found. See photo below.
- FUNCTIONAL AREA:** Throughout different portions of the building.
- LOCATION:** On ceilings.
- DESCRIPTION:** 2 X 24 Ceiling tile, drop-in ceiling tile, fissured pattern. See photo below. (No ceiling tile or mastic in this building was discovered to contain asbestos.)

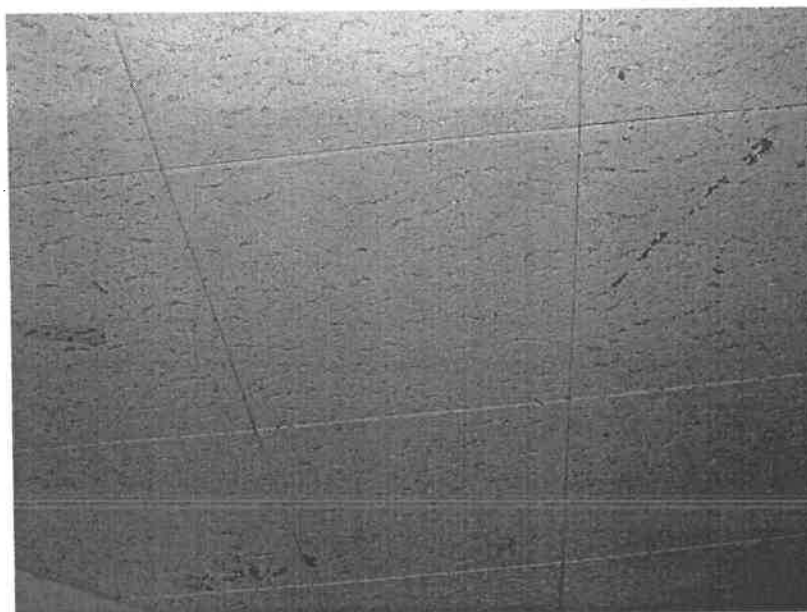
**DESCRIPTION:** 12 x 12 Ceiling tile, fissured pattern and adhesive. See photo below. (No ceiling tile or mastic in this building was discovered to contain asbestos.)

**NO ASBESTOS**

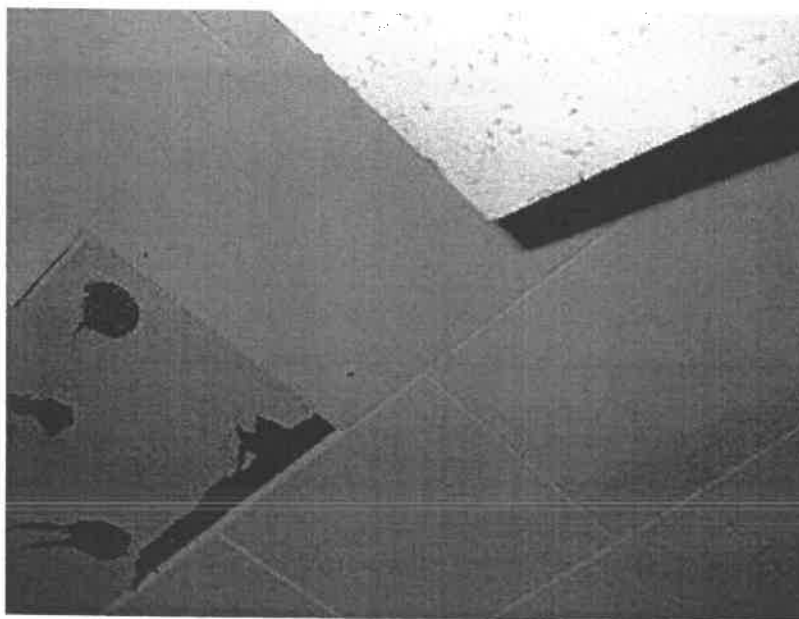
- BUILDING:** Arlington High School, A Building. See photo below.
- FUNCTIONAL AREA:** North classroom, home-ec on first floor above ceiling tile.
- LOCATION:** On ceilings.
- DESCRIPTION:** 12 x 24 Ceiling tile, smooth face and adhesive. See photo below. (No ceiling tile or mastic in this building was discovered to contain asbestos.)

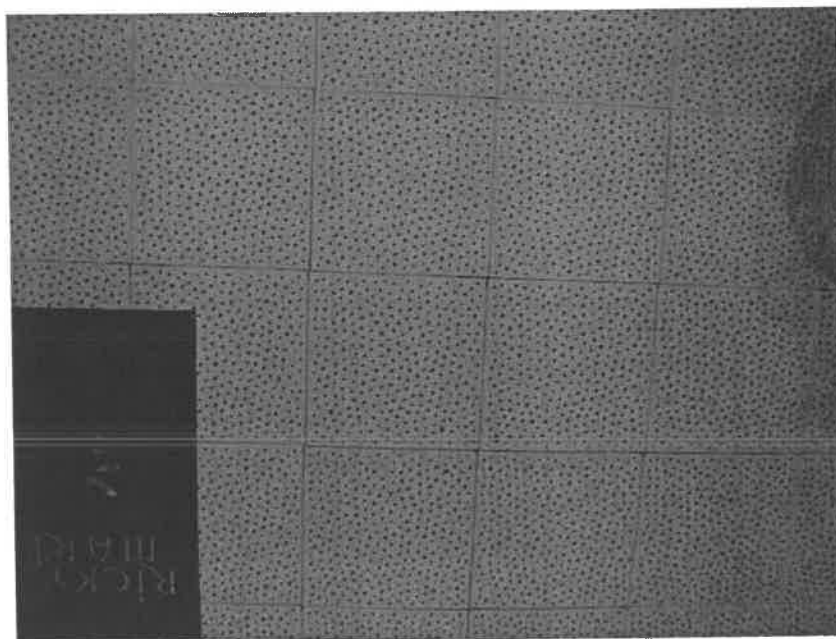
**DESCRIPTION:** 12 x 12 Ceiling tile, random hole ceiling tile and adhesive. This ceiling tile is located throughout the school district buildings and has been sampled many times. See photo below. (No ceiling tile or mastic in this building was discovered to contain asbestos.)

**NO ASBESTOS**

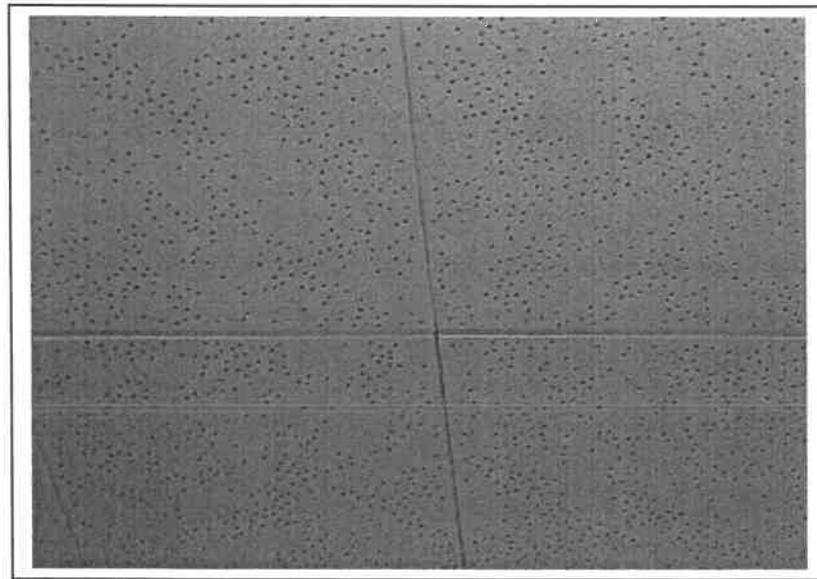
**DESCRIPTION:** 12 x 12 Ceiling tile, tiny random hole ceiling tile and adhesive. See photo below. (No ceiling tile or mastic in this building was discovered to contain asbestos.)

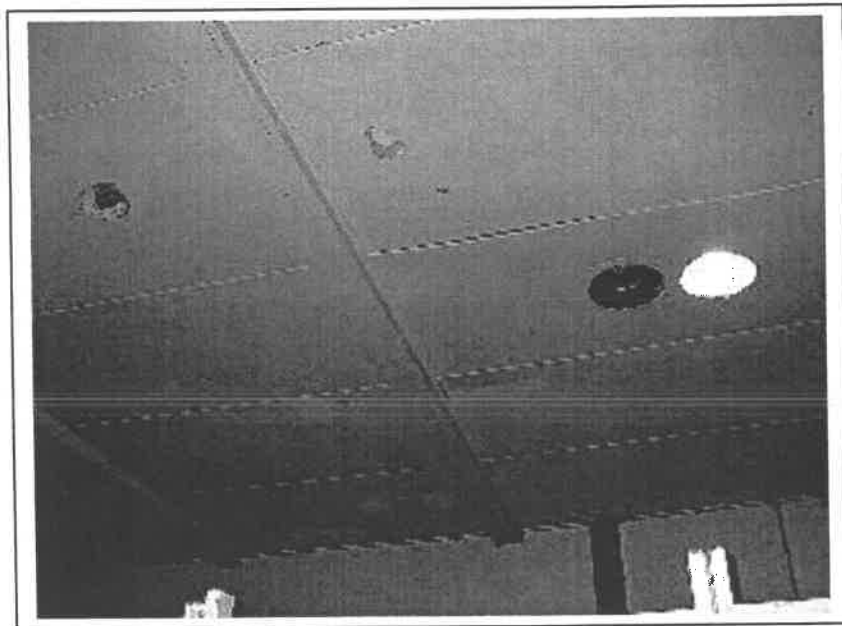
- BUILDING:** Arlington High School, A Building. See photo below.
- FUNCTIONAL AREA:** Where found on third floor storage and mechanical areas and second floor, NE classroom.
- LOCATION:** On ceilings.
- DESCRIPTION:** 4 x 8 Fiberboard ceiling panels. See photo below. (No ceiling tile or mastic in this building was discovered to contain asbestos.)

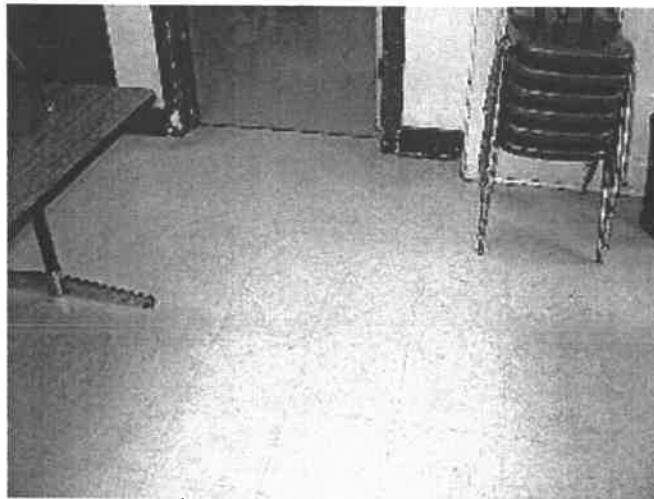
**DESCRIPTION:** This 12 X 12 floor tile is not ACM, but the associated adhesive used with the floor tile is asbestos containing.

**All 12 X 12 floor tile in the building is non-asbestos or less than 1% asbestos. However, the mastic for all 12 X 12 floor tile is asbestos containing.**

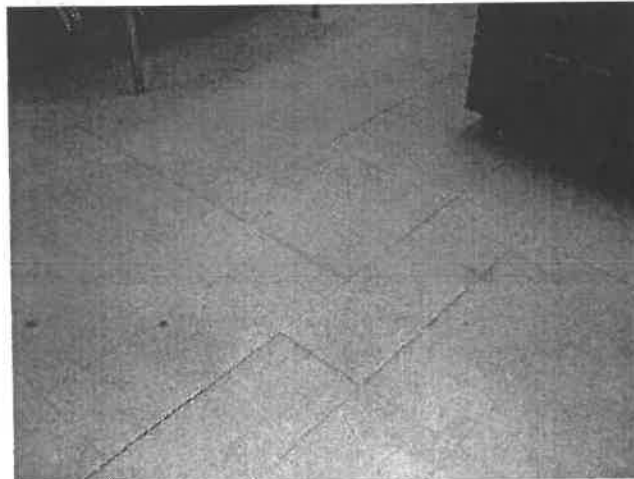
DESCRIPTION: This 12 X 12 floor tile is <1% ACM. The mastic for this tile was shown to be non-asbestos. This was the only floor tile mastic in the building, shown to be non-asbestos. Through the inspector's experience, it is unlikely that all of the mastic for this floor tile is non-asbestos. Therefore, the inspector has determined this mastic / adhesive to be assumed ACM.

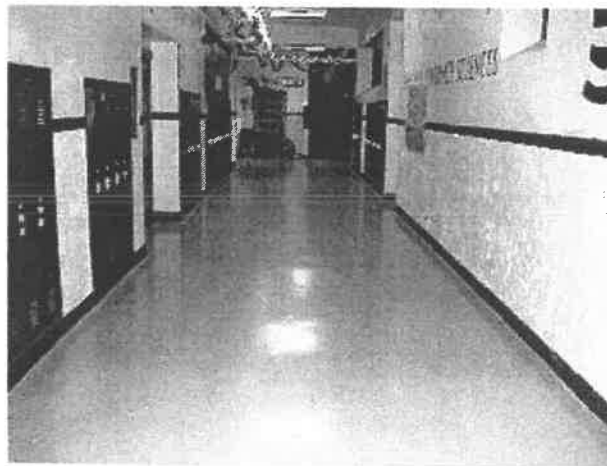
**DESCRIPTION:** This paper and mastic was probably adhered to the floor as a vapor barrier at some time during the past. The paper itself is not asbestos but the mastic used with the paper is asbestos containing. Again, this paper was probably used throughout the entire basement floor at one time. It wore off or was removed from many of the rooms.

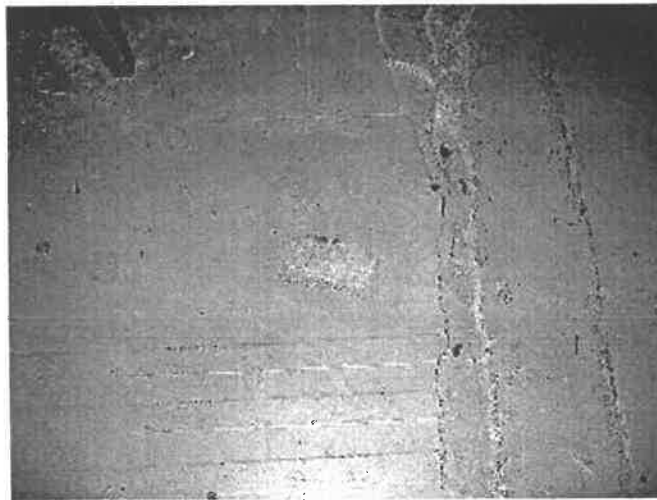
- BUILDING:** Arlington High School, A Building
- FUNCTIONAL AREA:** Basement floor, paint room in the wood shop.
- LOCATION:** On the floor. See site plan for locations.
- DESCRIPTION:** This vinyl floor sheeting is asbestos containing flooring material. This yellow vinyl floor sheeting has been painted gray and is in the South part of the wood shop.

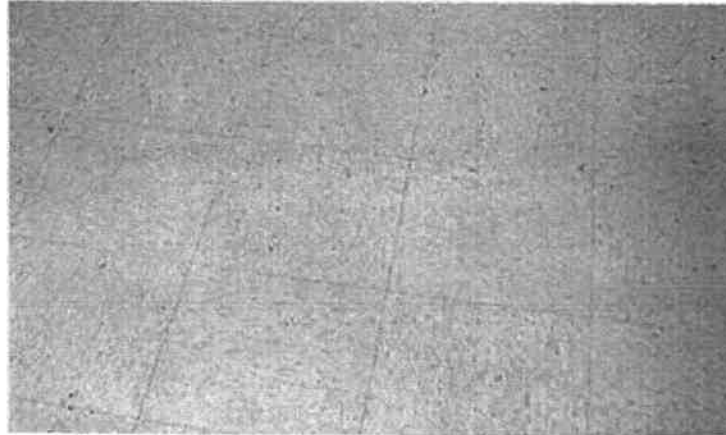
**DESCRIPTION:** This 12 X 12 floor tile is not ACM, but the associated adhesive used with the floor tile is asbestos containing.

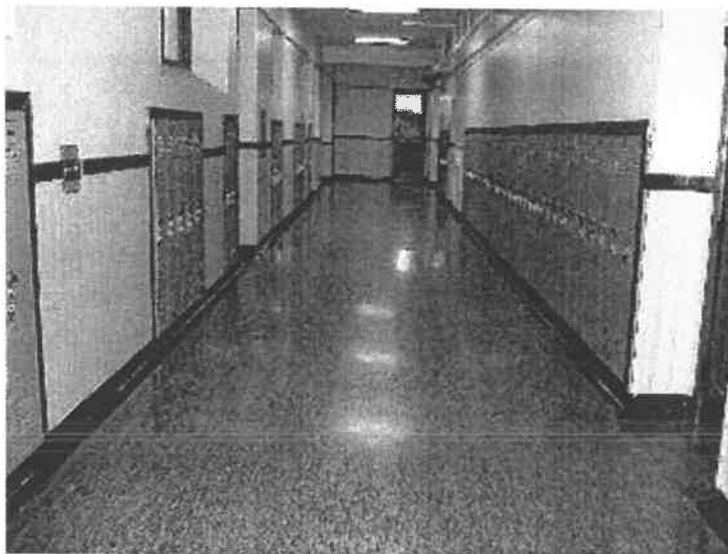
**DESCRIPTION:** Traditional, non-asbestos linoleum floor sheeting.

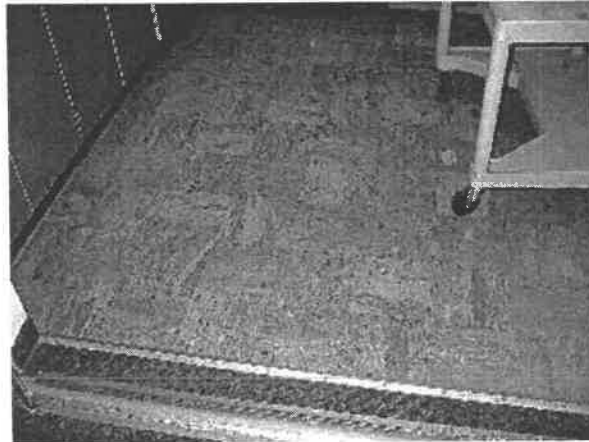
- BUILDING:** Arlington High School, A Building
- FUNCTIONAL AREA:** Second floor of the building in North classroom. See site plan.
- LOCATION:** On floors.
- DESCRIPTION:** This 9 X 9 floor tile is presumed to be ACM including the associated adhesive used with the floor tile is presumed to be asbestos containing.

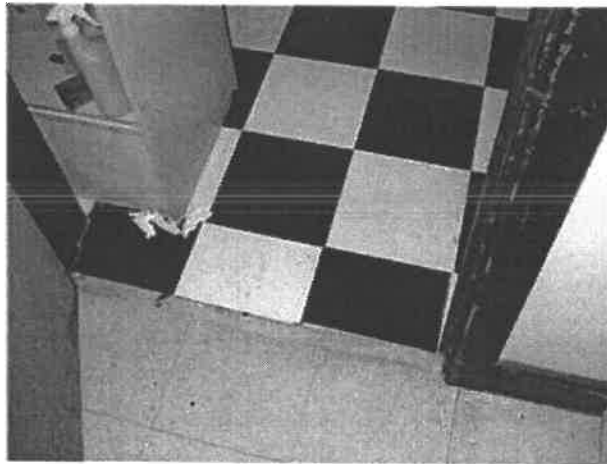
**DESCRIPTION:** This 12 X 12, black & white floor tile is not ACM. The associated adhesive used with the thicker-white, 12 X 12 floor tile under this floor tile is asbestos containing.

**All 12 X 12 floor tile in the building is non-asbestos or less than 1% asbestos. However, the mastic for all 12 X 12 floor tile is asbestos containing, with the exception of homogeneous area #38, the thin (vinyl) black & white tile. This vinyl tile is over existing 12 X 12 floor tile with asbestos mastic.**

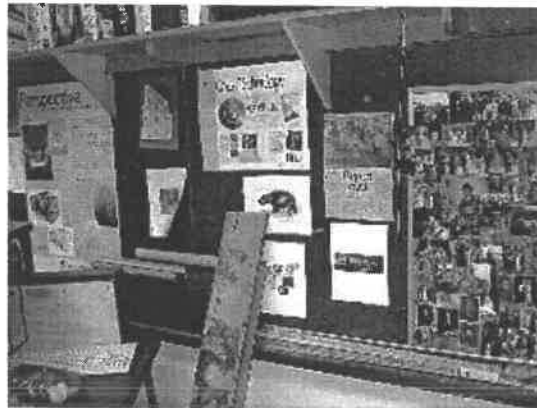
- BUILDING:** Arlington High School, A Building
- FUNCTIONAL AREA:** Throughout the building.
- LOCATION:** On walls in classrooms.
- DESCRIPTION:** Through the inspector's experience, these chalkboards are typically non-asbestos. An assurance samples was taken and these chalkboards were shown to be non-asbestos containing chalkboards.

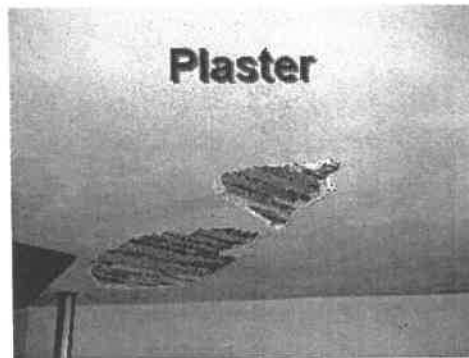
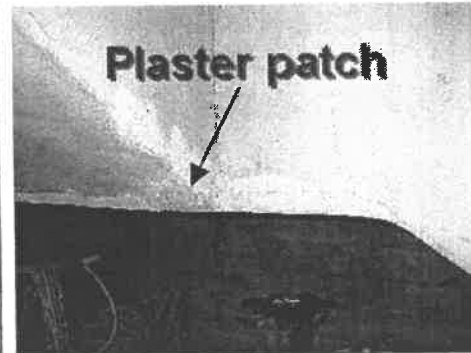
DESCRIPTION: This lath & plaster system was installed when the building was originally constructed. Many samples were taken of this lath & plaster system and this wallboard system is shown to be a non-asbestos containing material.

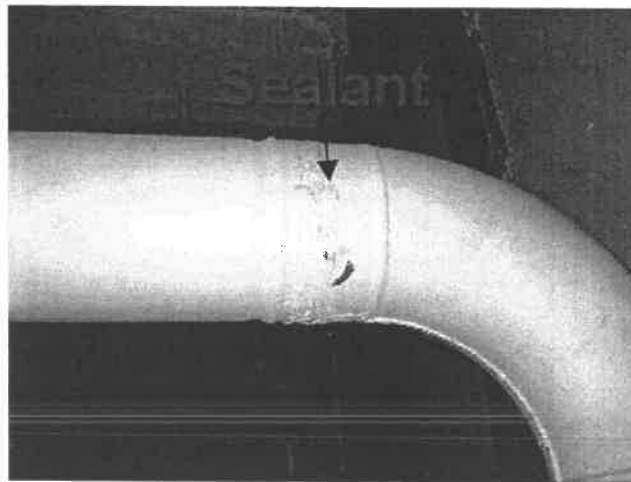
**DESCRIPTION:** Sealant material on the metal collector tubes, as seen below.

**NO ASBESTOS**

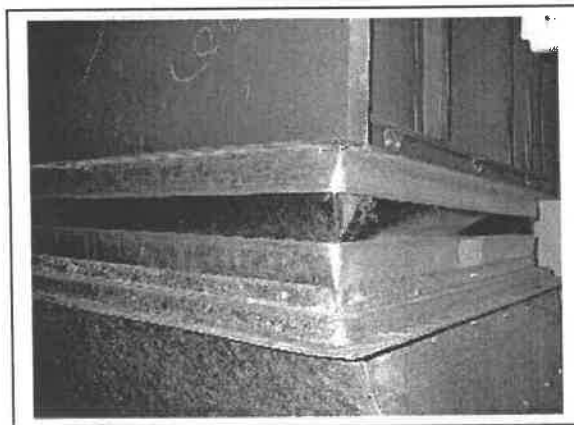
**DESCRIPTION:** Rubber, vibration cloth or also known as flex connectors for mechanical ductwork. The inspectors experience has shown this to be a non-suspect, rubber flex connector.

**NO ASBESTOS**

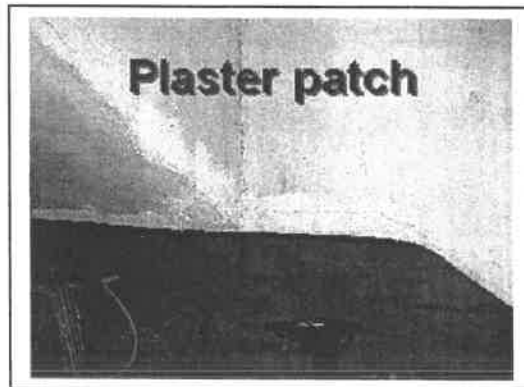
**DESCRIPTION:** This lath & plaster system was installed when the building was originally constructed. Samples were taken of patches seen in the wallboard system and was shown to be a non-asbestos containing material.

**NO ASBESTOS**

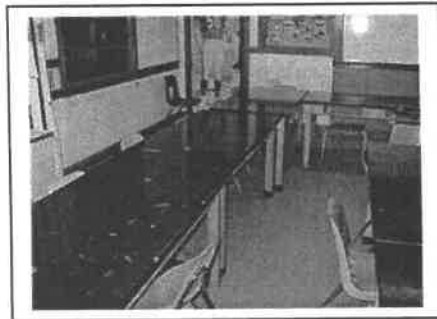
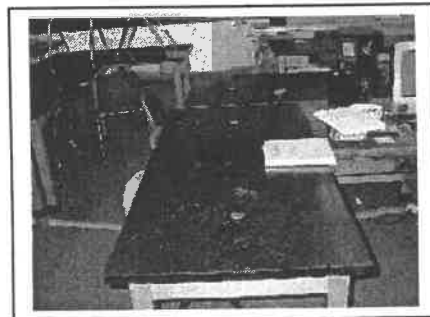
**DESCRIPTION:** Black science tables appear to be the asbestos chemstone table tops, at first glance. Upon closer examination, these are not the traditional chemstone science countertops and therefore, an assurance sample was taken.

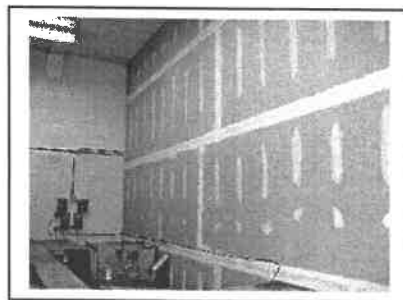
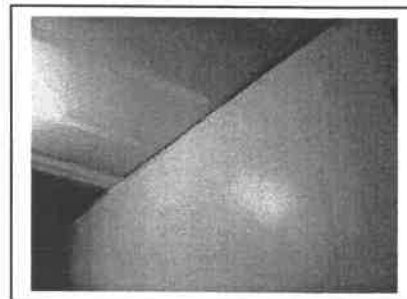
**DESCRIPTION:** This GWB wallboard was installed during remodels of the building. Samples were taken of this GWB wallboard and taping compound and this wallboard was shown to be a non-asbestos containing material.

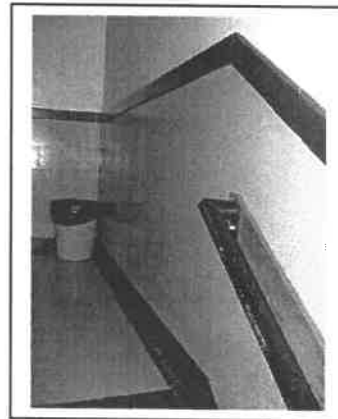
**DESCRIPTION:** This tile and carpet used as a wainscote for the lower portion of the interior walls and was installed during 1999 and 2000. Only non-suspect adhesive and materials were used. This tile is seen in below photo's.

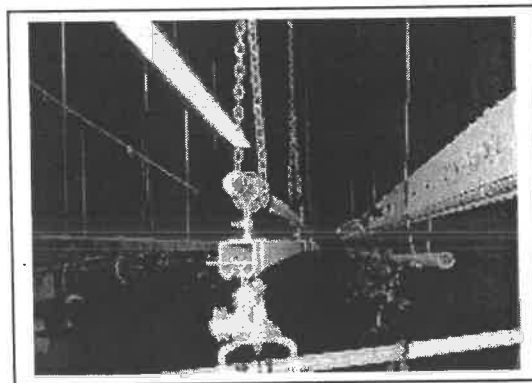
DESCRIPTION: The wiring on the stage lighting is traditionally asbestos containing and this wiring was presumed to be asbestos containing. These asbestos containing electrical cords are white in color and should be treated as asbestos containing or sampled prior to working on or replacing.

During this inspection of the building, no asbestos cords were seen. All of the stage lighting was a newer, non-asbestos electrical cord. However, the older asbestos inspection reports indicate that there are asbestos electrical cords on stage lighting and this caution is in case of the white asbestos cords being found.
